# Rock House Inspections

19239 CR 219, Ovalo, TX 79541 Phone: 325-660-9869

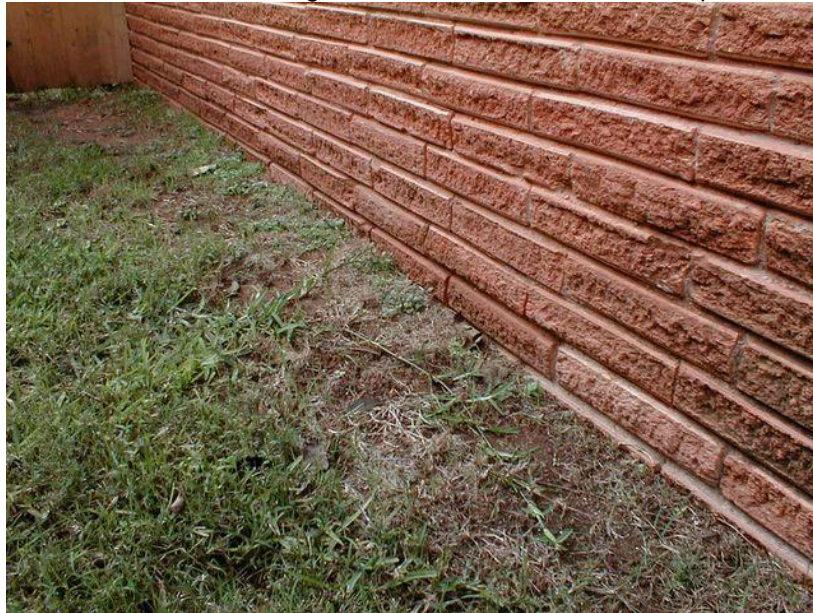
Picture shows dirt covering lowest courses of brick and weep holes.

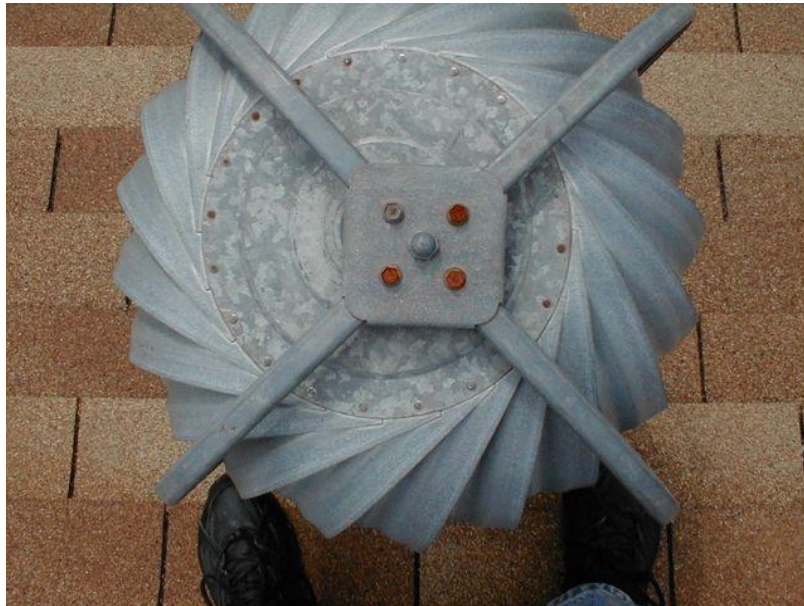
Flashing cement does not fill downhill side of roof penetration. Shingles laid on top of cement leaving dam at downhill side. This may allow water to penetrate under the shingles. Application of additional cement will provide a seal to prevent under-shingle penetration by water.

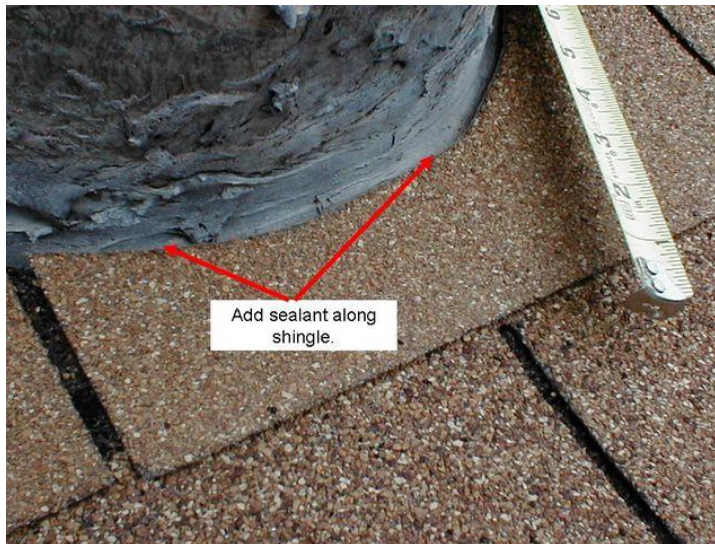
I=Inspected				NI=Not Inspected	NP=Not Present	R=Not Functioning or In Need Of Repair
I	NI	NP	R	Inspection Item

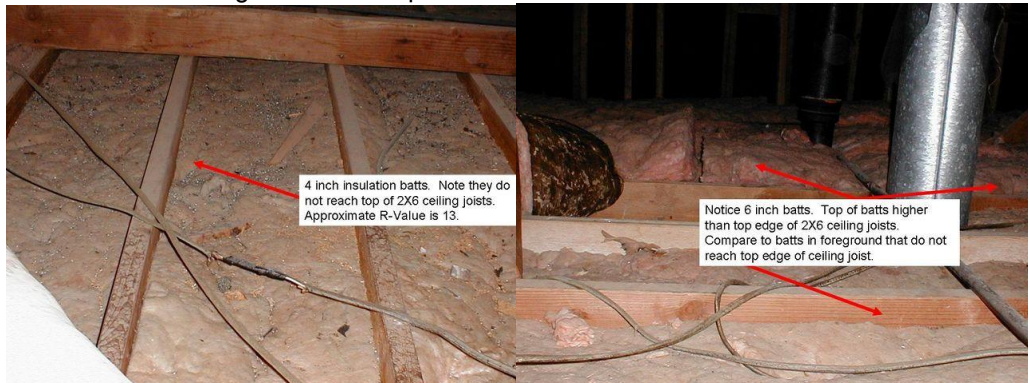
Above two pictures show 4 in. batts and thicker over-layment of 6 in. batts

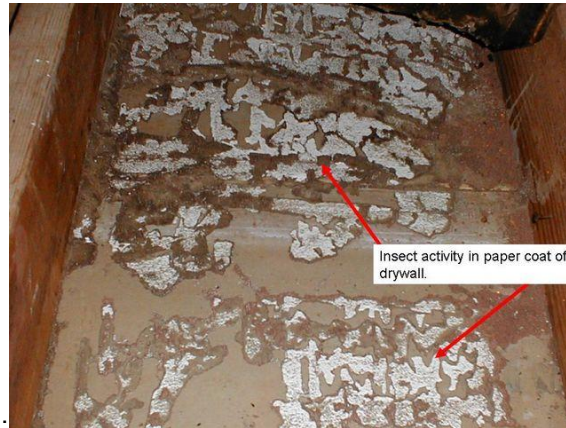
Picture shows 4 in. batt of insulation turned up revealing furrows created by insects

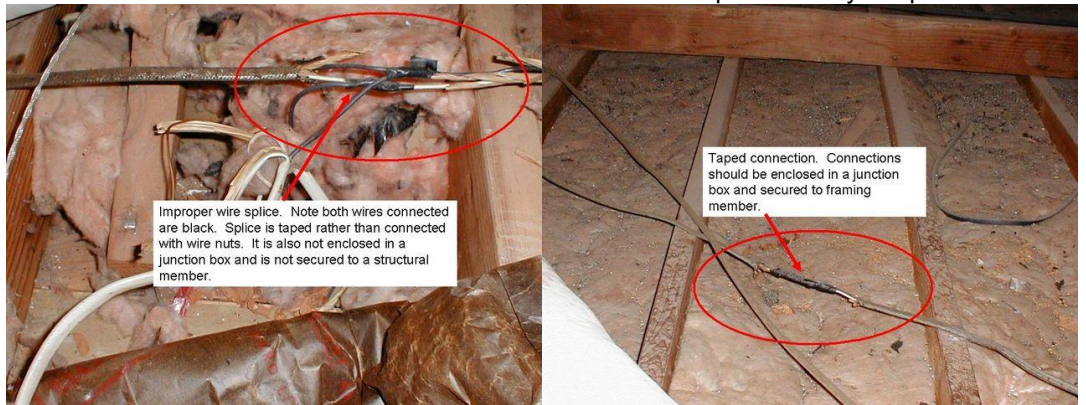
**Outlet and Switches**

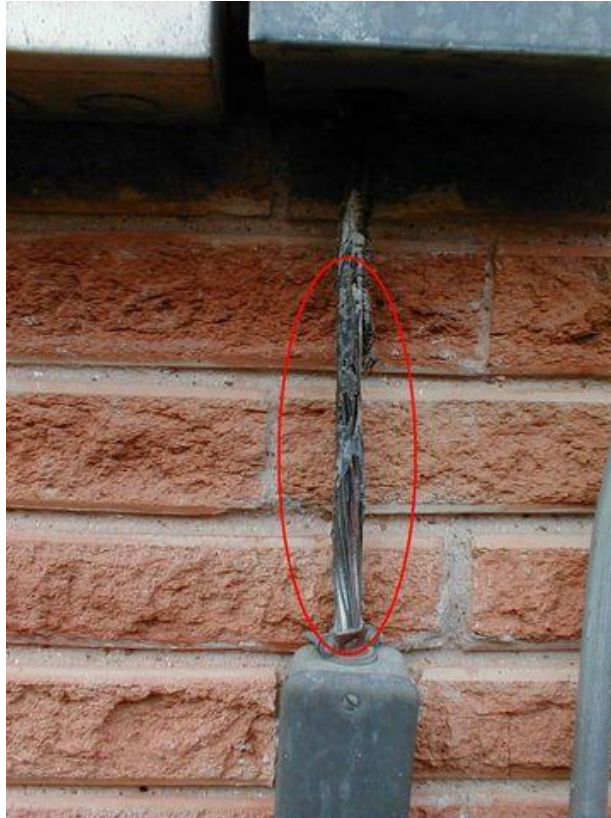
**Ground Fault Circuit Interrupt (GFCI) Safety Protection**

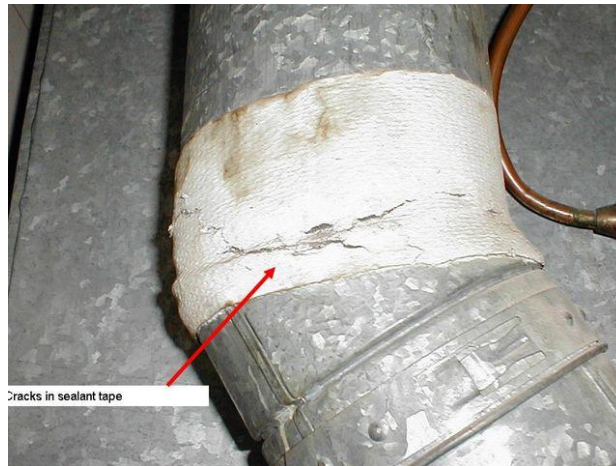
I=Inspected				NI=Not Inspected	NP=Not Present	R=Not Functioning or In Need Of Repair
I	NI	NP	R	Inspection Item

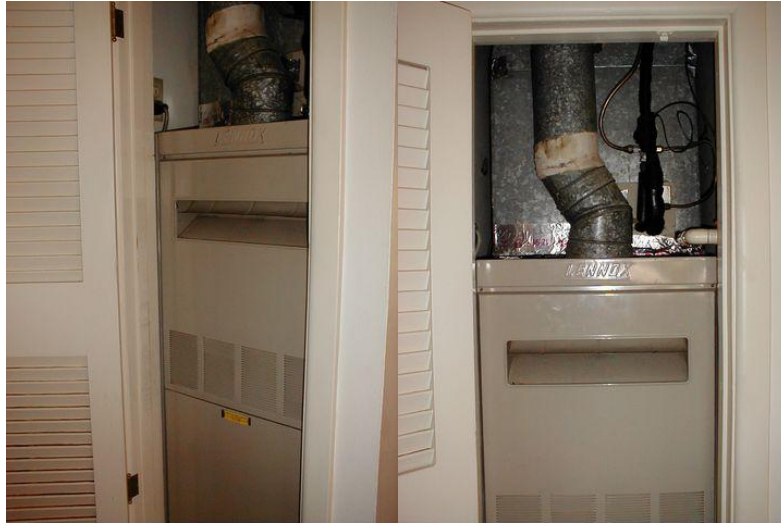
Furnace enclosure too small for installed unit. Both sides of furnace closer than 3 inches to wall and front of furnace 5 inches from door.

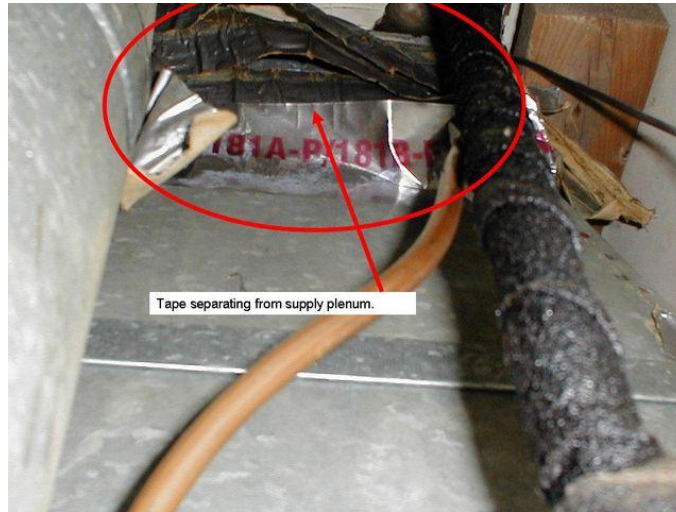
I=Inspected				NI=Not Inspected	NP=Not Present	R=Not Functioning or In Need Of Repair
I	NI	NP	R	Inspection Item

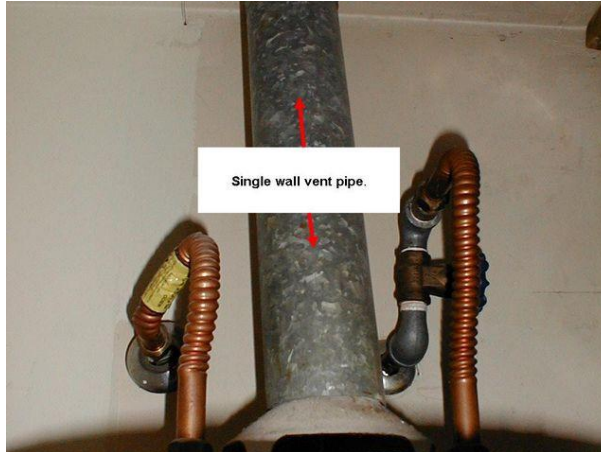
**Water Heater Temperature and Pressure Relief Valve**

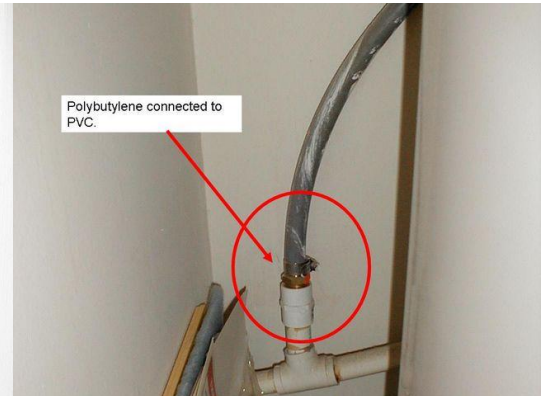
Pictures show right and left sides of water heater. Gray polybutylene wraps around water heater behind and to left connecting to PVC pipe from A/C condensate drain. Gray poly pipe has a temperature rating of 100 degrees C or 212 degrees F.
